DISTRESS IN THE TARMAC

Because the airport site is located in the floodway of Bangkok's eastern suburbs, it requires both effective flood protection and drainage systems to avoid problems caused by water seepage into the sand blanket under the airport's taxiways and runways, writes PROF WORSAK KANOK-NUKULCHAI

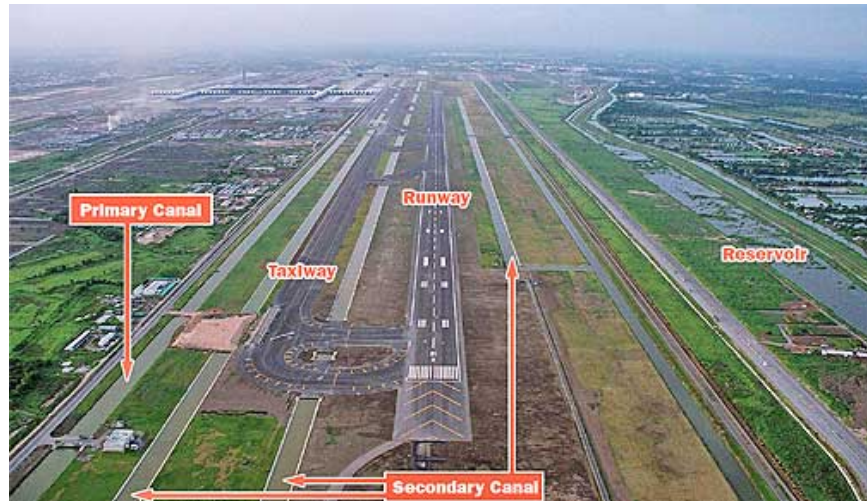
Overview of east runway, taxiways and the drainage system.

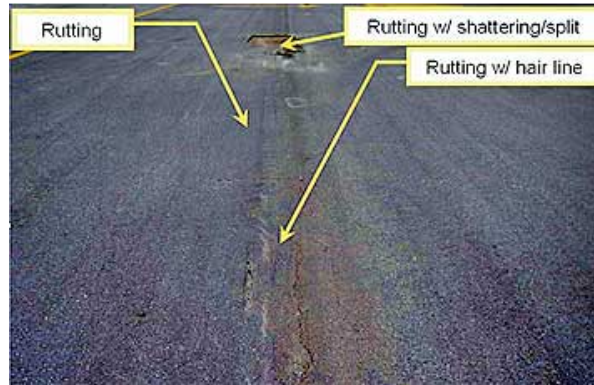
taxiways and taxilanes, in the form of rutting, rutting with shattering and split, and rutting with hairline cracks (figure1). Since then, a similar pattern of failure has developed heavily in five of the six taxilanes and along the east parallel taxiway. Although both runways are still in good structural condition, plastic deformation of the asphalt wearing course was observed near the takeoff position. The extent of the damage is summarised in the table below.

Figure 1: Typical distress in the taxiways and taxilanes.

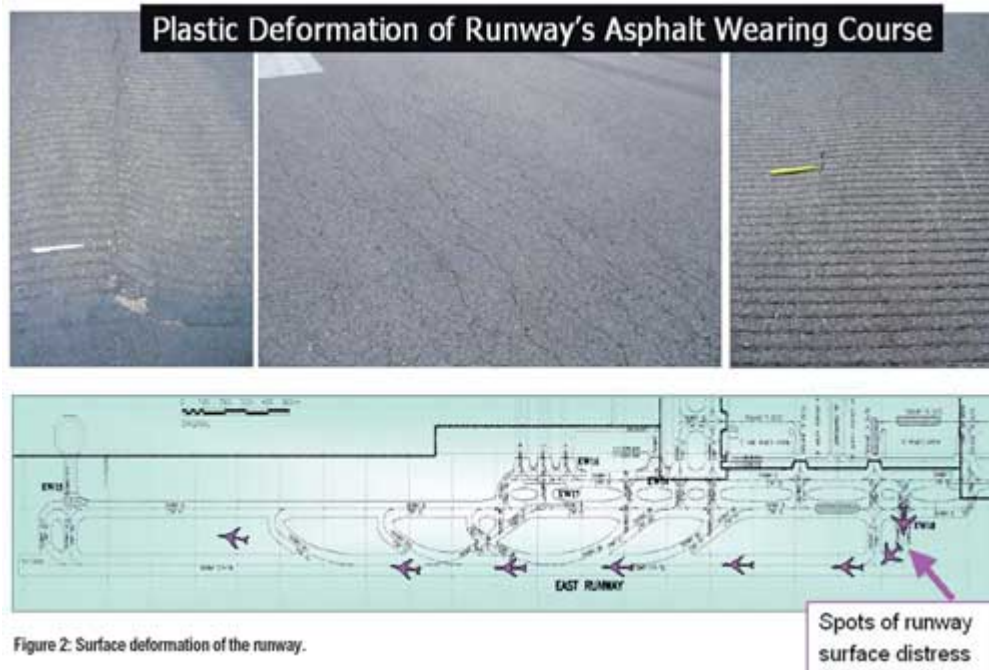
Plastic deformation was observed on the wearing course at the turn-around segment of the taxiway leading to the takeoff position of the runway (Figure 2). This location is normally under maximum load when the plane takes off with a full load of fuel. The high shearing stress that causes plastic deformation was imposed by braking, accelerating or turning traffic. Plastic deformation is greatest at high temperatures, especially for the AC 60/70 binder grade used in this case. The occurrence of the plastic deformation at this location is therefore a common phenomenon and only routine maintenance is required to repair this type of distress. Aside from this surface distortion, both runways are in good structural condition.

Figure 2: Surface deformation of the runway.

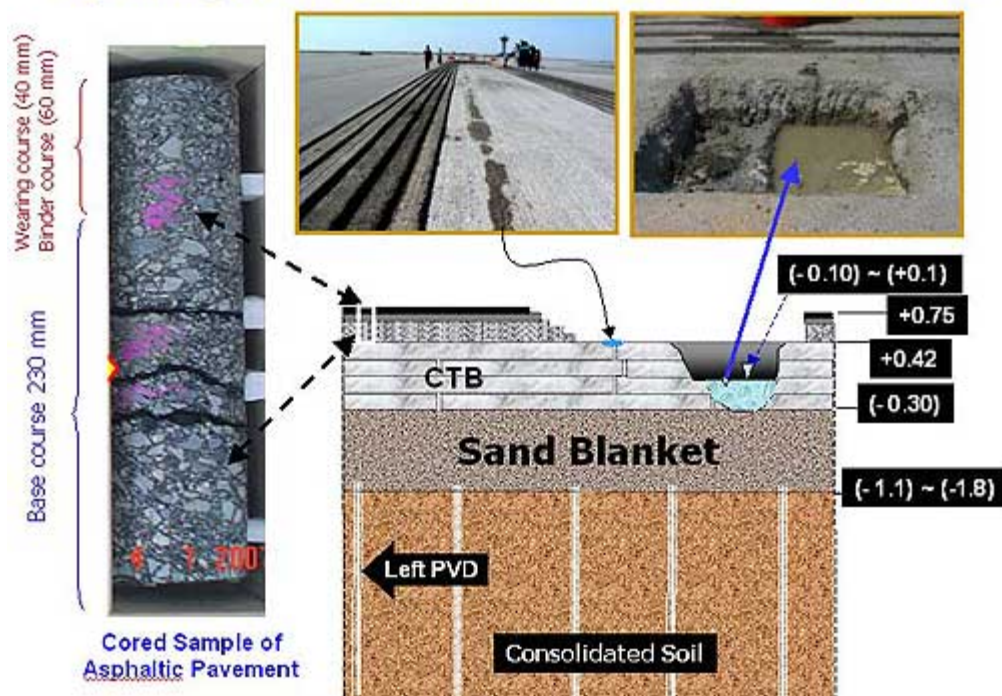
Initial investigation was made by coring the asphalt concrete pavement at a diameter 100 mm throughout its 33 cm thickness from the damaged areas (Fig. 3). The following observations can be made:

- All core samples from damaged area show evidence of asphalt stripping at the base course, a typical effect of soaking water, while core samples from undamaged areas show good condition.
- The water had infiltrated into and confined in the asphalt concrete base course for a long period. Thus, the base course has been immersed in and impaired by the water.

- As a result of asphalt stripping, asphalt binder was separated from aggregate surface, leading to premature loss of strength and stability of the base course.
- The load of the aircraft had then impaired the failed asphalt concrete pavement, causing rutting on the surface.

To expose the cement-tested base (CTB) for visual inspection, an area of asphalt concrete pavement was milled at the damaged area of the taxiway. It was evident that there was no sign of damage or subsidence in the CTB. However, traces of water seepage were clearly observed (Fig 3) along the rim of the expansion joints in the CTB. This evidence of seepage further hinted that a large quantity of water might still be trapped in the sand blanket.

Figure 3: Illustration of milled pavement in the taxiway T11, a core sample of asphalt concrete, trace of the water seepage at CTB joint and the test pit.

On January 31, a test pit (Fig 3) was dug on Taxiway T11, where damage was found to be extensive. After the excavation went through CTB and exposed the top surface of the sand blanket, water seeped through the sand immediately until the water level reached about 20 cm above the sand

blanket (or roughly at +0.0 MSL). The water stayed at that level even when attempts were made to clear the water.

In its press release issued on 15 February 2007, the Engineering Institute of Thailand (EIT) strongly recommended that, similar to a first-aid treatment, trapped water should be drained out urgently to minimise the potential spread of cracks on taxi lanes, taxiways, and even on runway. This immediate action should be carried out with the consent and cooperation of all concerned parties including the project management consultants, the designers and the contractors.

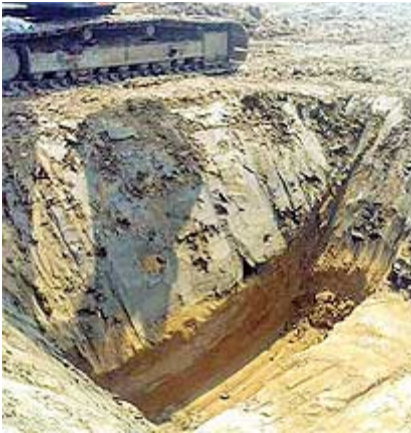
Interestingly, to prove that water in the sand blanket is fully confined with no connection outside, a deep excavation was made nearby, but outside the pavement area. After the excavation, the dug hole was completely dry. No sign of water from the sand blanket had seeped into this empty hole.

Excavation to test the connectivity of the trapped water.

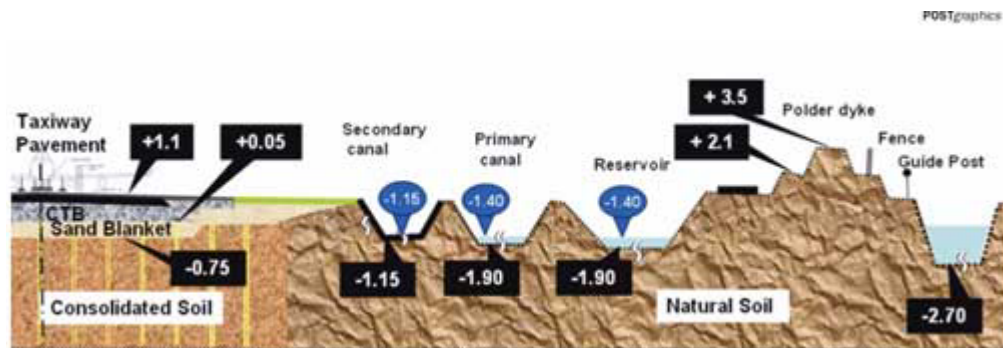
Because the airport site is located in the floodway of Bangkok's eastern suburbs, it requires both effective flood protection and drainage systems. The aim is to prevent flooding from flash floods, as well as to drain away rainwater in the catchments of the airport compound. The design of the polder system includes the perimeter polder dike, internal drainage system, two pumping stations and a perimeter road (Fig 4).

Figure 4: Profile of the flood protection and the drainage system.

With the design assumption that no rain water runoff can leak into the sand blanket, no subsurface drainage system exists to systematically drain trapped water from the sand blanket. This might be a weakness in the design criteria of the airfield pavement.
