DISTRESS IN THE TARMAC

Because the airport site is located in the floodway of Bangkok's eastern suburbs, it requires both effective flood protection and drainage systems to avoid problems caused by water seepage into the sand blanket under the airport's taxiways and runways, writes PROF WORSAK KANOK-NUKULCHAI

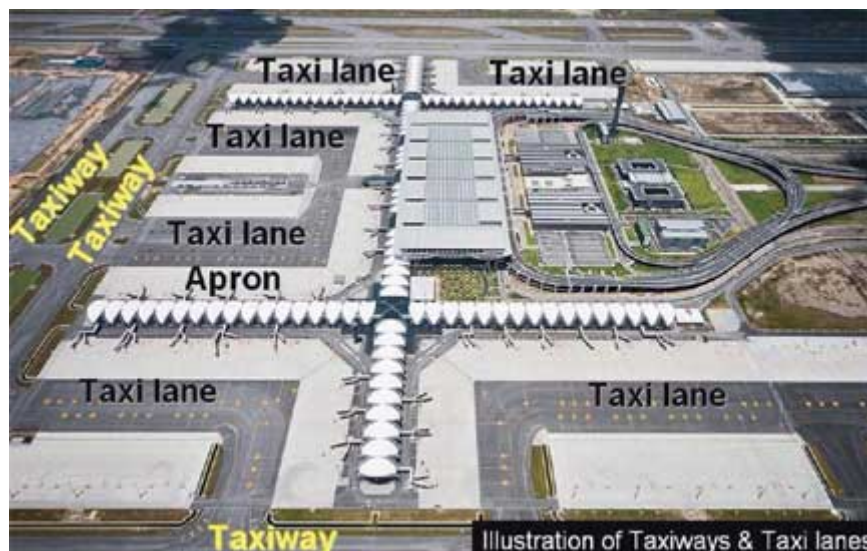
Illustration of taxiways and taxilanes.

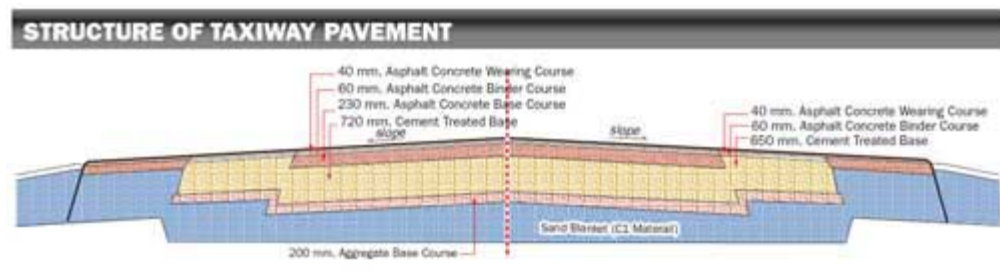
Suvarnabhumi airport covers an area of 20,000 rai (3,200 hectares). In its first phase, the airfield serves its hourly 112 flights with two runways, six taxiways and six taxilanes. The tarmac consists of three layers of asphalt concrete, namely the base course (23 cm thick), the binder course (6 cm thick), and the wearing course (4 cm thick). Underneath are four layers of the cement-treated base (CTB), 18 cm. thick each, sitting on top of the sand blanket (approximately 80 cm thick) left over from the ground improvement process.

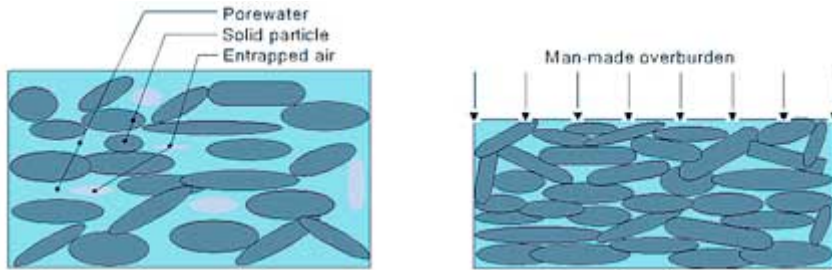
Figure A1: Natural and consolidated soft clay deposits.

To be suitable for airfield pavement, pore water in the soft soil must be squeezed out to result in water content around 80%. Thus, the soft clay is transformed into medium stiff clay. This consolidation process can be accelerated by a modern technique using Prefabricated Vertical Drains (PVD).

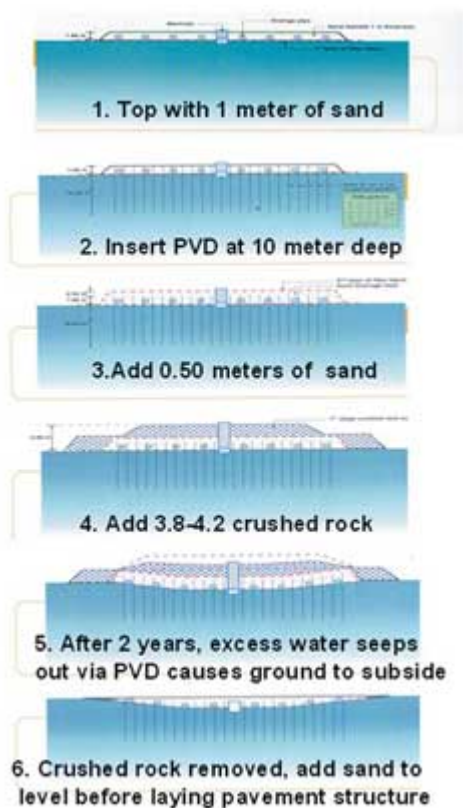
Figure A2: Consolidation process of soft clay under the airfield pavement.

PVD is a plastic tube core wrapped in a filter jacket, made of non-woven polyester or polypropylene geotextiles or synthetic paper. PVDs drain soil by squeezing out pore water, a process that can be accelerated by adjusting the spacing of PVDs. In this process, water flows a lot more quickly horizontally towards the drain and then vertically along the drains towards the permeable drainage layer at the top. The step-by-step procedure of consolidation using PVD is illustrated in Figure A2.
